Vol. 2, Issue 1, June 2024 eISSN: 3025-518X

Strength Evaluation of Combined New and Old Plates Welded Joint: Case of Anggada XV Tug Boat

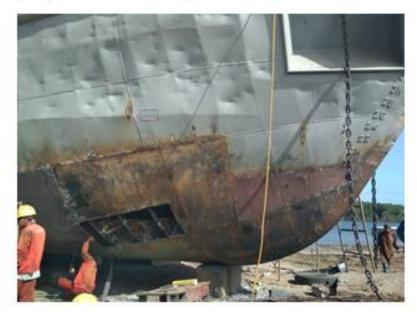
Figure 1. Replating place of the bottom near forepeak

In this research, the welding plates were taken from the Anggada XV tug boat, which was established in 1987. The shipping line is limited to around Semayang Port Balikpapan. The replating place is the bottom near the forepeak, as shown in Figure 1. The principle dimension of the Anggada XV tug boat is in Table 1.

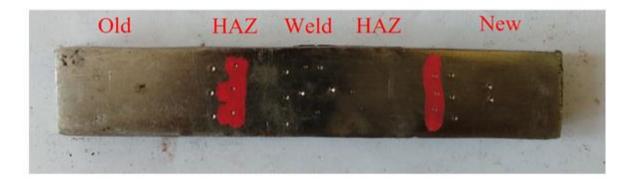
Figure 5. Specimenn of hardness test

A Brinell testing machine was used for the hardness test, emphasizing 100 KgF. The ASTM E10-15 standard was used for the brinnel test. Six times, indentation was applied in each area of the old plate, the affected zone (HAZ) of the new plate was heated, and metal was welded to obtain the mean value of the bridal test.

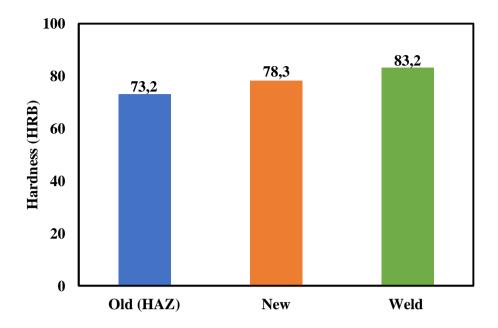
Figure 8. Hardness test results

Figure 8 shows the value of the hardness test. The highest value of the hardness test is obtained in the weld metal region with 83.2 HRB. The lowest hardness test is in the HAZ region because this area has a non-uniform microstructure [11]. On the other hand, In the base metal of the new plate, the hardness test value is 78.3 HRB.
